2015 PAVEMENT CONDITION INDEX (PCI) STUDY **EXECUTIVE SUMMARY**

**BISMARCK
MUNICIPAL
AIRPORT (BIS)** BISMARCK, ND

FEDERAL AVIATION ADMINISTRATION
A.I.P. NO. 3-38-0000-013-2015

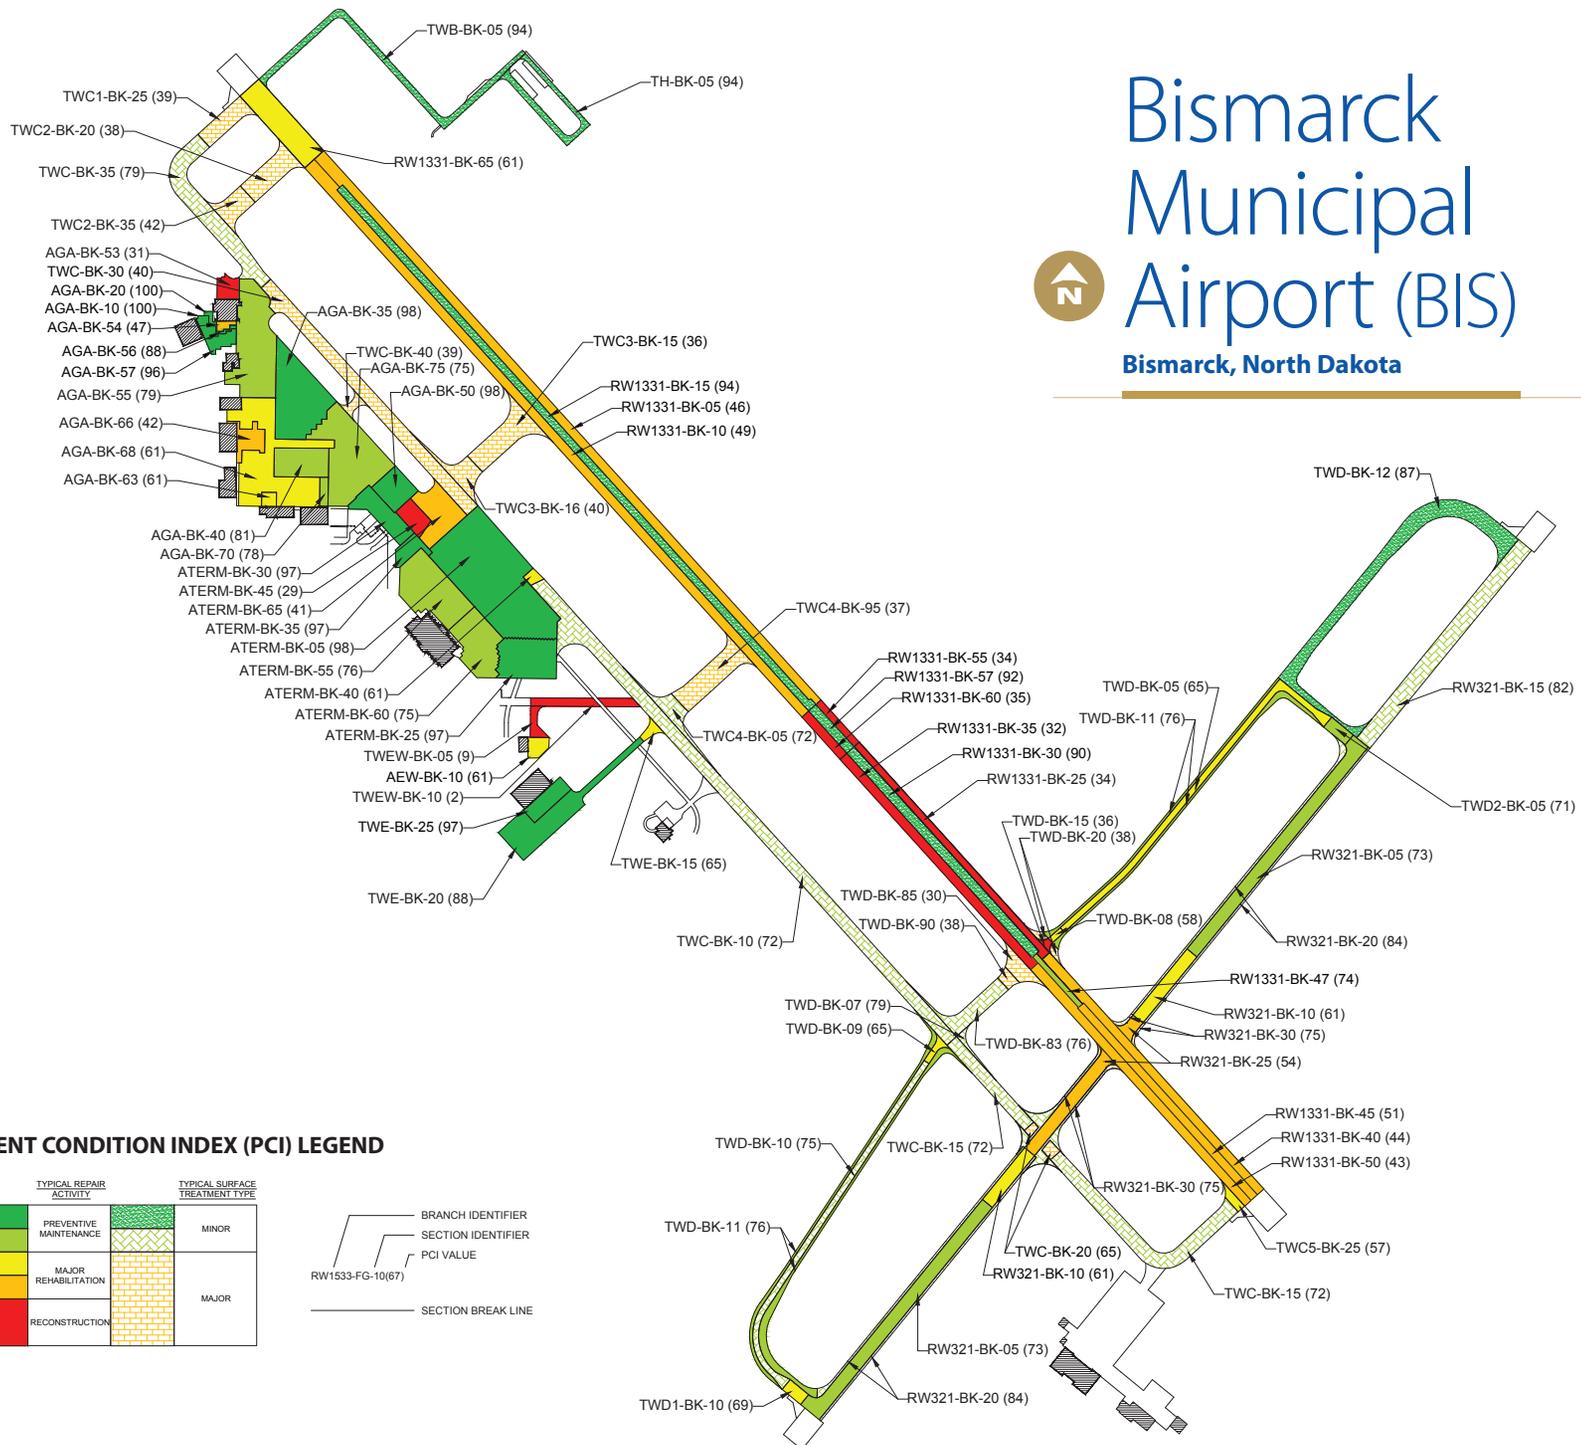
Bismarck Municipal Airport (BIS)

The **Bismarck Municipal Airport** was divided into multiple sample sections and an overall area-weighted pavement condition was assigned to each section. **The airport was inspected in September of 2015 and has an overall area-weighted PCI of 69, with conditions ranging from 2 to 100.**

This data is summarized on the PCI map shown on page 10. Numerous distresses were identified on the airport’s pavements. Most notable distresses include but are not limited to:

- **Medium-severity weathering**
- **Low- and medium-severity L & T cracking**
- **Medium-severity raveling**
